High-Frequency Acoustic Imaging of L Lake, Savannah River Site, South Carolina

by Keith J. Sjostrom, Rodney L. Leist, Thomas S. Harmon, Jr.

Final report

105 p.: ill.; 28 cm. — (Technical report; GL-97-17)

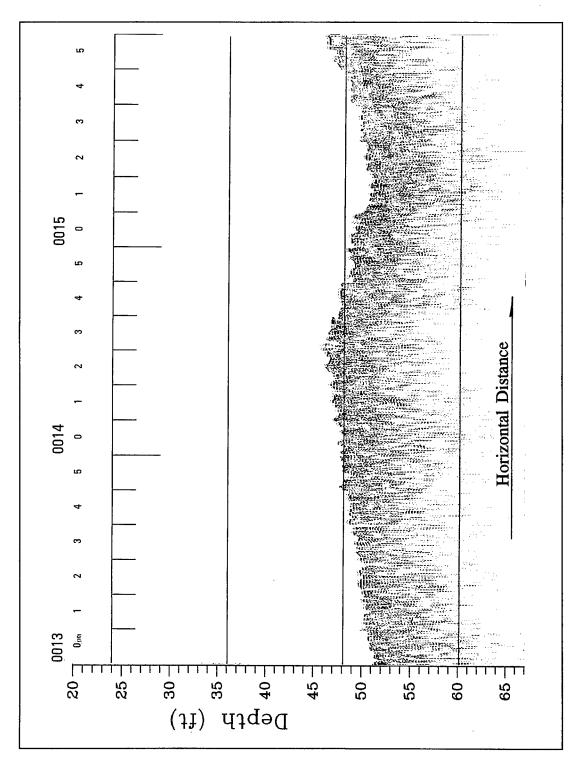
Typical seismic reflection signatures in L Lake as illustrated along survey line PL01 (files 0130-0155) Figure 8.

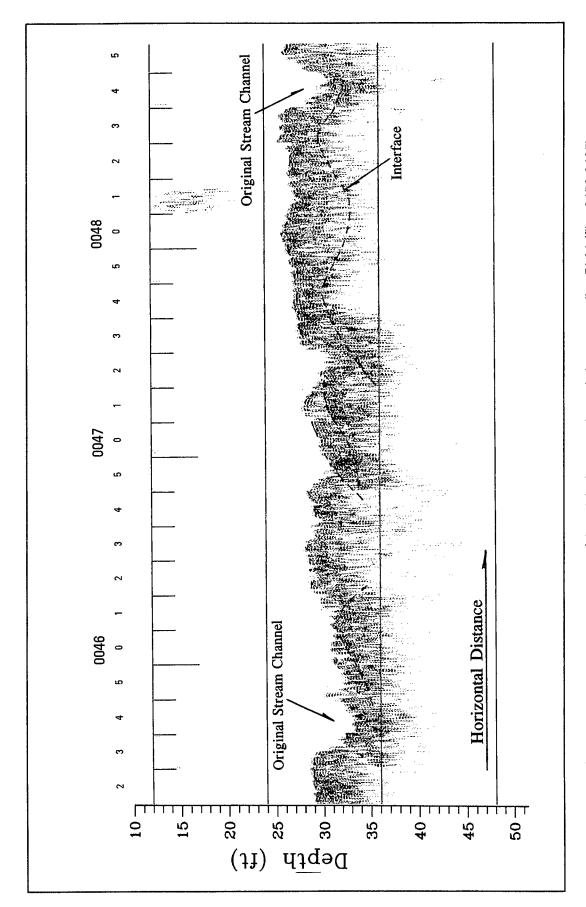
Sediment interfaces are detected in areas where the seismic survey lines intersect the original stream channel such as along survey line PL01 (files 0452-0485) presented in Figure 9. These interfaces likely represent bedding planes from the erosion and redeposition of sediment along the channel margin. The seismic signatures near files 0462-0464 (see Figure 9) seem to indicate a possible buried trench having a depth of approximately 8 ft. Closer inspection of the aerial photo (see Plate 1) shows mounds and possible burial pits in the vicinity but side scan sonar data positions indicate that these features are approximately 25 m (82 ft) to the left of the survey line. Therefore, these reflection signatures are likely not indicative of a burial trench but rather near-surface sediment interfaces. Other areas in which sediment interfaces are detected are along the side slopes of the reservoir upstream of the dam. These areas are where the majority of the earthwork activity took place during construction of the reservoir. A portion of the seismic record collected along survey line PL01 (files 0080-0100) is presented in Figure 10.

Seismic reflection data collected over an area of the original stream channel along survey line PL01 (files 0452-0485) Figure 9.

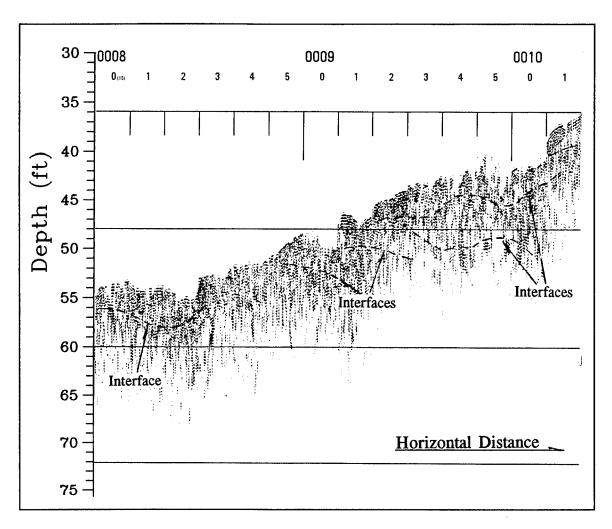
Figure 10. Seismic reflection data collected along survey line PL01 (files 0080-0101) indicating near-surface sediment interfaces

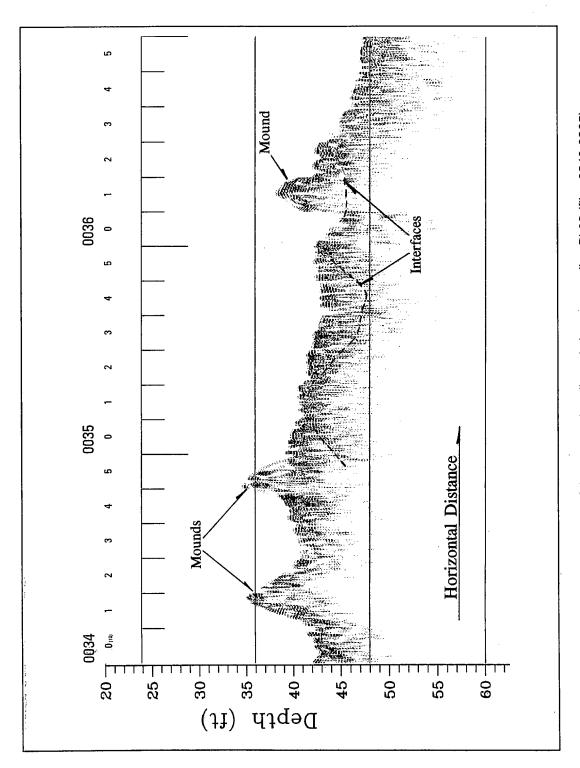
The principle targets of the investigation are the numerous mounds and possible burial pits dotted across the reservoir bottom as clearly visible in the aerial photograph (see Plate 1). An example of the seismic signatures collected across burial mounds is presented in Figure 11. In this figure, the data collected along survey line PL02 (files 0340-0365) illustrate the signatures of three mounds typical of those located throughout the reservoir basin. Each mound is 5 to 7 ft in height and approximately 15 to 20 ft in width. The seismic reflection data also reveal that there are likely no burial trenches beneath the mounds. However, in some instances, there are slight depressions underneath the mounds as shown in Figure 11 at file 0361.

Figure 11. Seismic reflection signatures of three mounds collected along survey line PL02 (files 0340-0365)

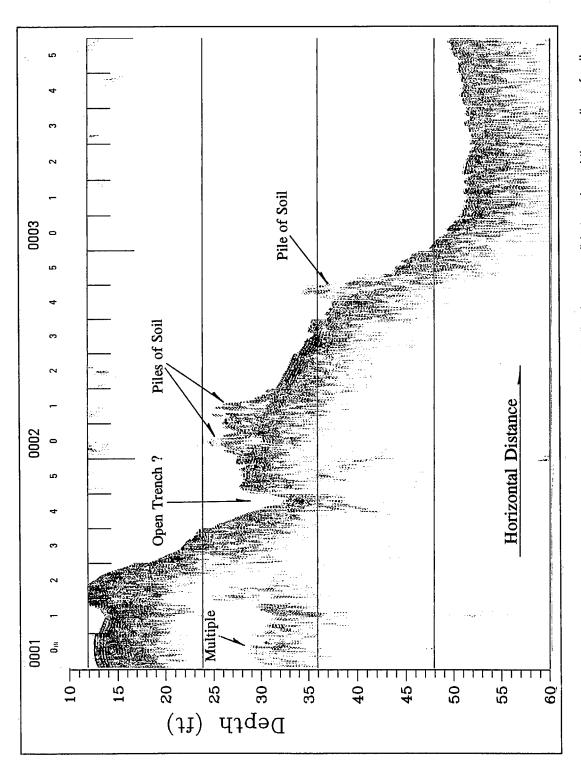
Seismic reflection data collected along survey ling PL14 indicating a possible trench and three piles of soil Figure 12.

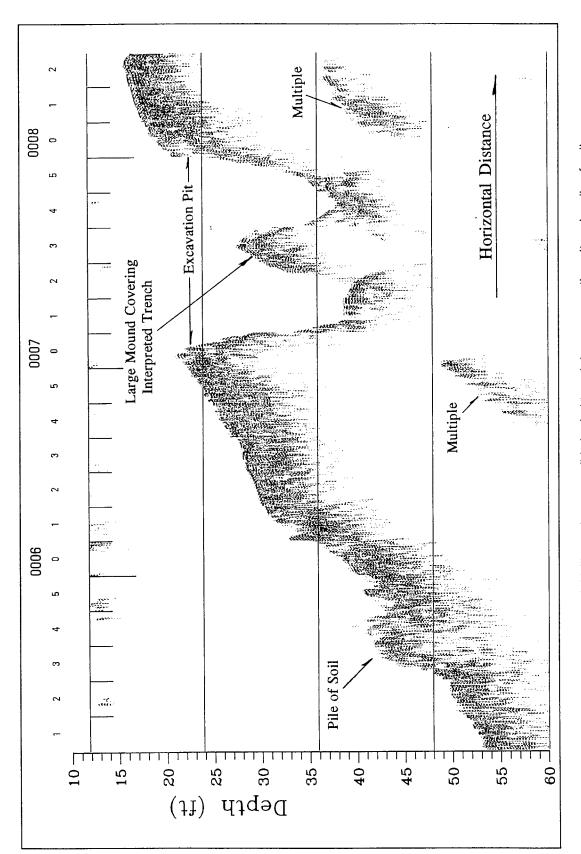
Figure 13, Seismic data long survey line PL13 illustrating a possible buried trench in an excavation pit and a pile of soil

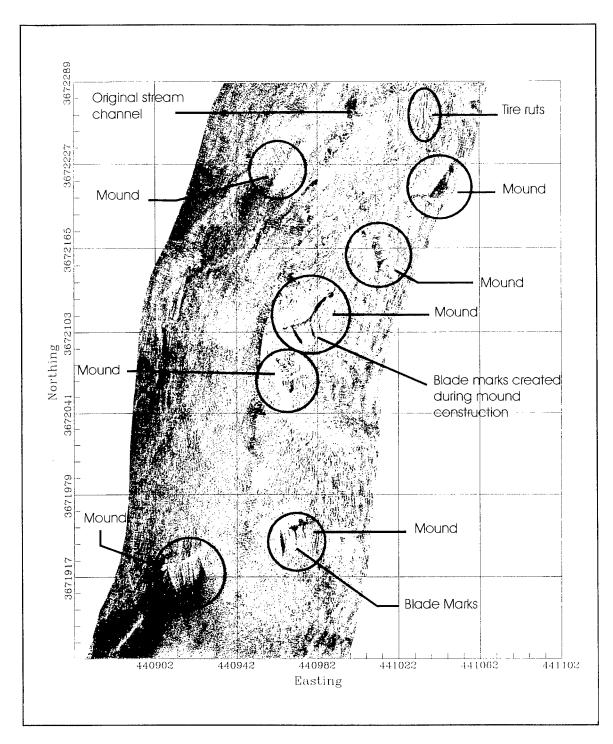
Figure 14. Sonar images of seven mounds along survey line SL08. Also note the blade marks created during mound construction

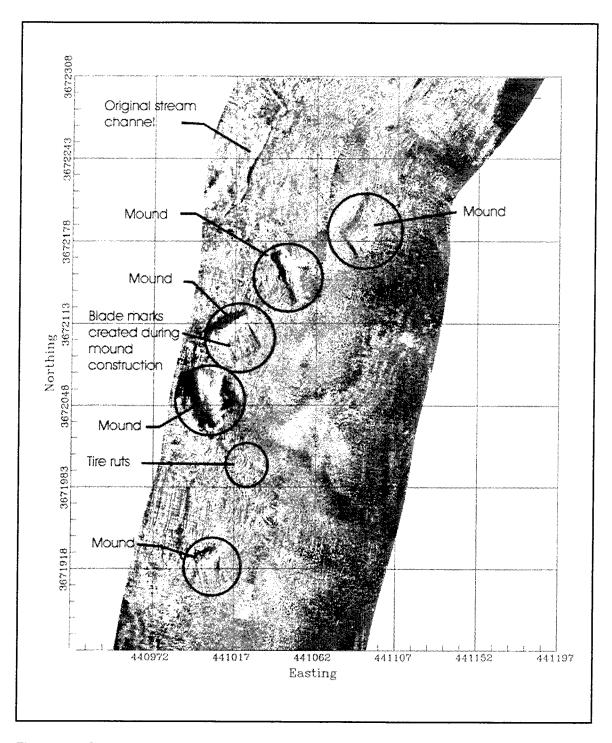
Figure 15. Sonar images of five mounds along survey line SL09. Tire ruts are also interpreted near the mounds

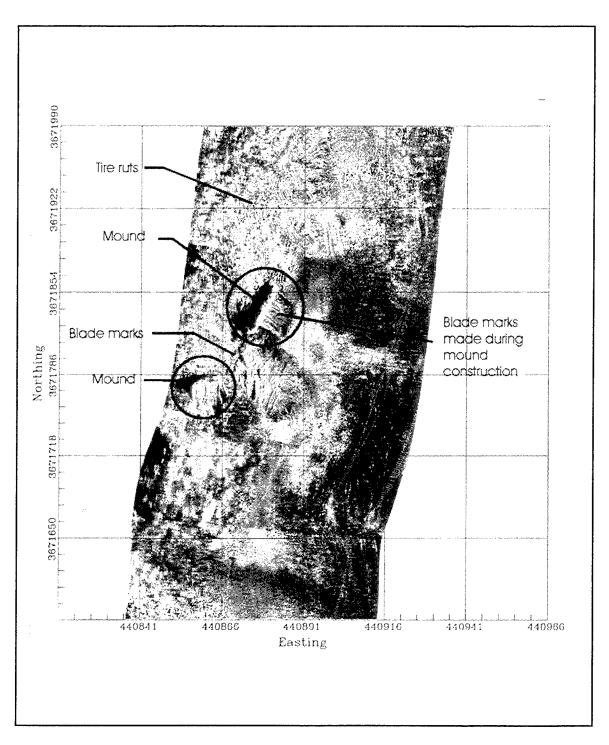
Figure 16. Sonar images of two mounds surrounded by tire ruts and blade marks as detected along survey line SL07

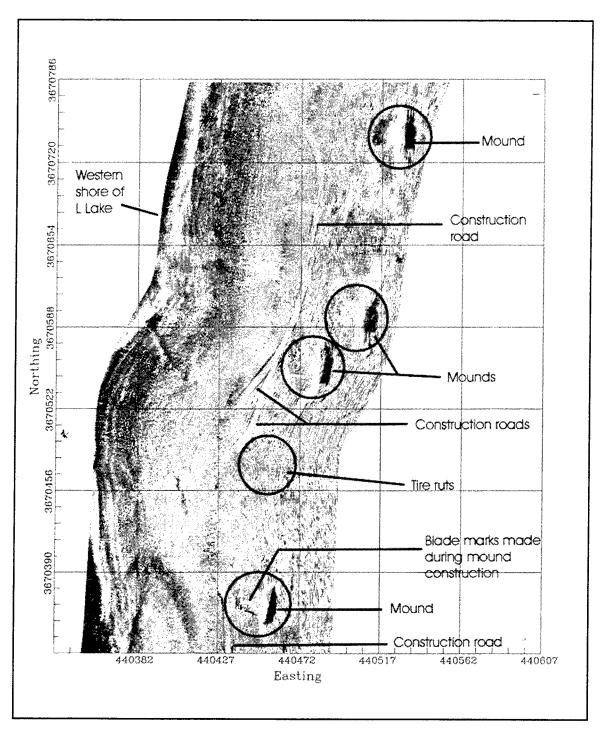
Figure 17. Sonar images of at least four mounds along survey line SL06. A number of construction roads are also visible

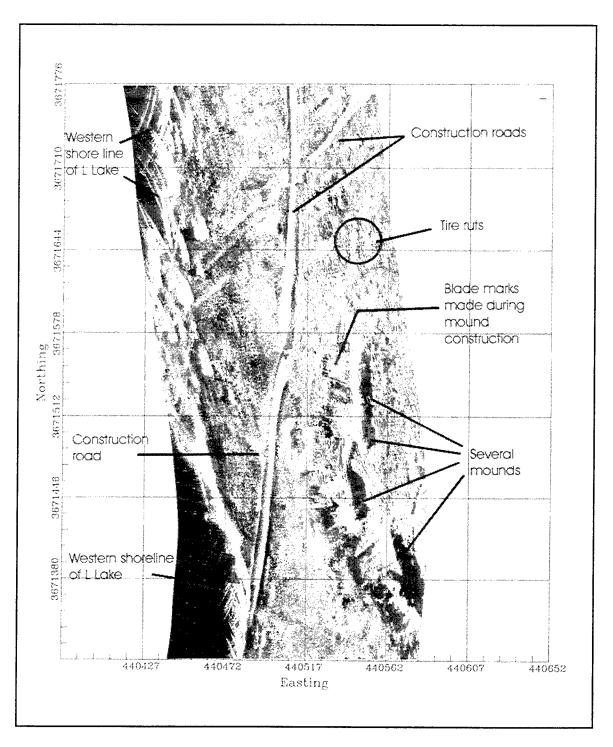
Figure 18. Sonar images of several mounds along one of the construction roads as detected along survey line SL06. The left side of the image is the western shoreline of the lake

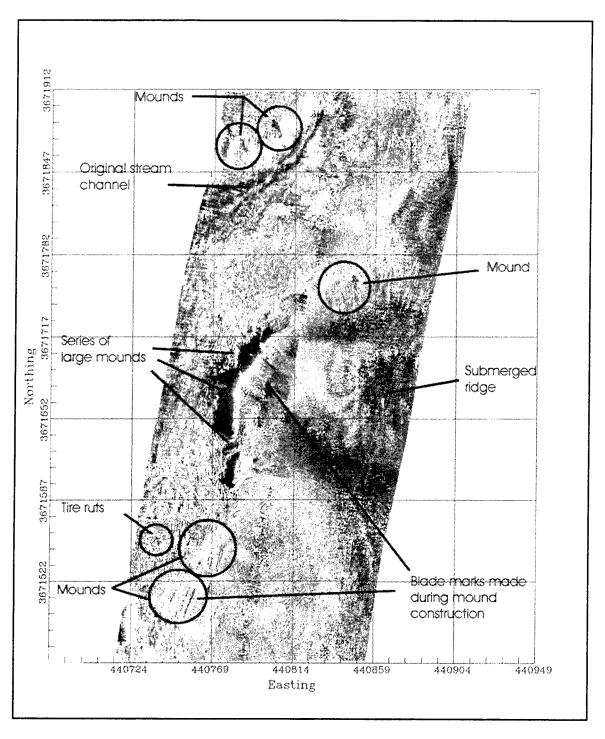
Figure 19. A group of large mounds at the base of a submerged ridge as interpreted along survey line SL03. Smaller mounds and the original stream channel are also detected

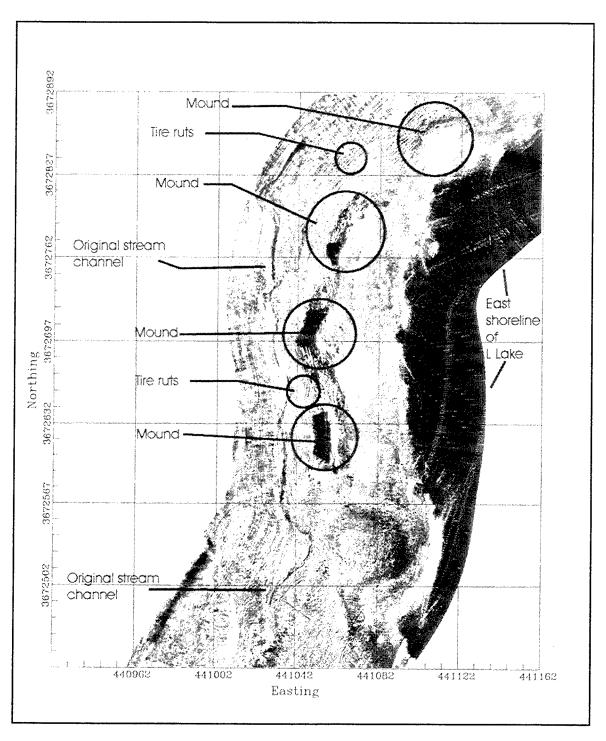
Figure 20. Sonar images of three mounds next to the original stream channel as detected along survey line SL07

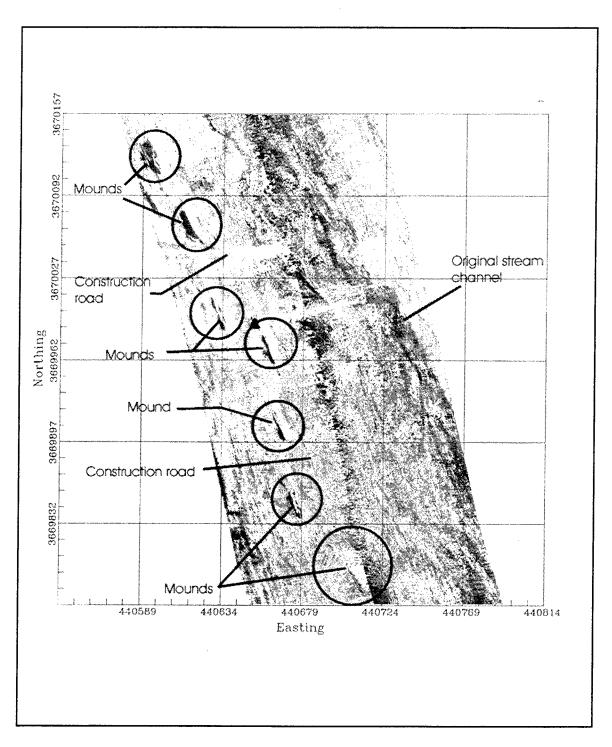
Figure 21. Sonar images of several small mounds along survey line SL03. The original stream channel and construction roads are also detected

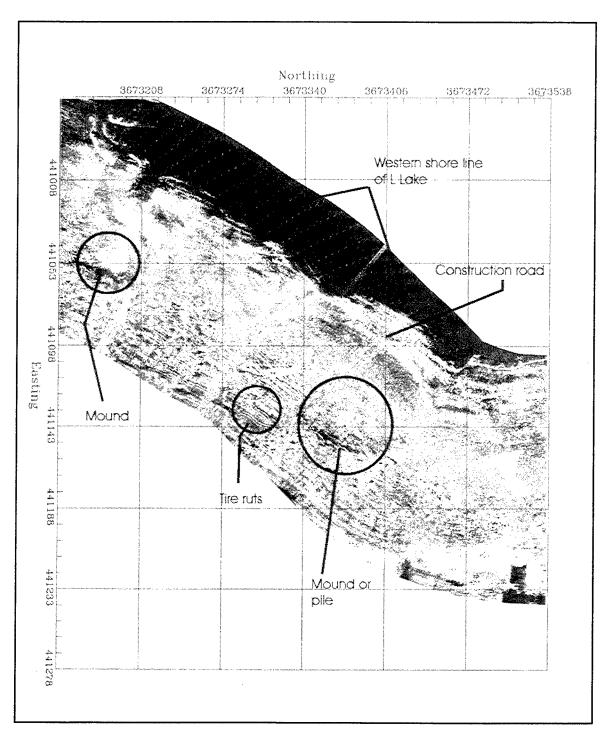
Figure 22. Sonar images of two mounds near the start of survey line SL06. Interpreted tire ruts are also visible

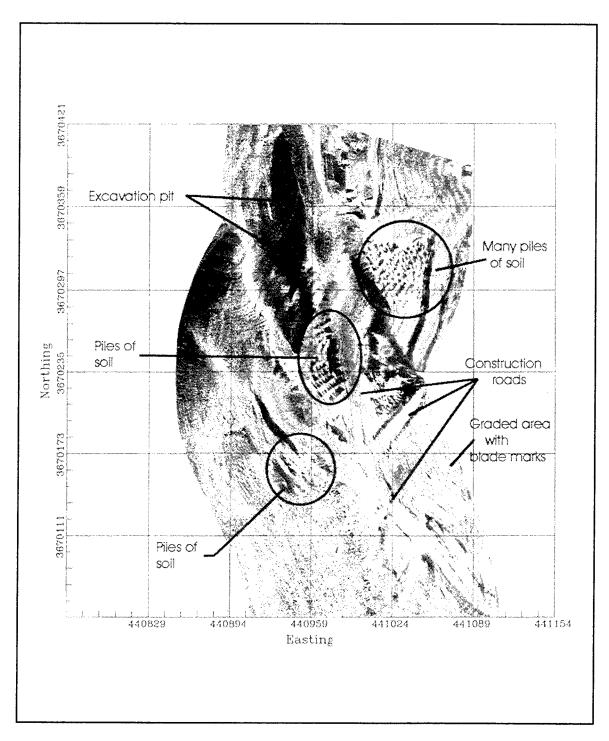
Figure 24. Sonar images of piles of soil, excavation pits, and construction roads as detected along survey line SL14

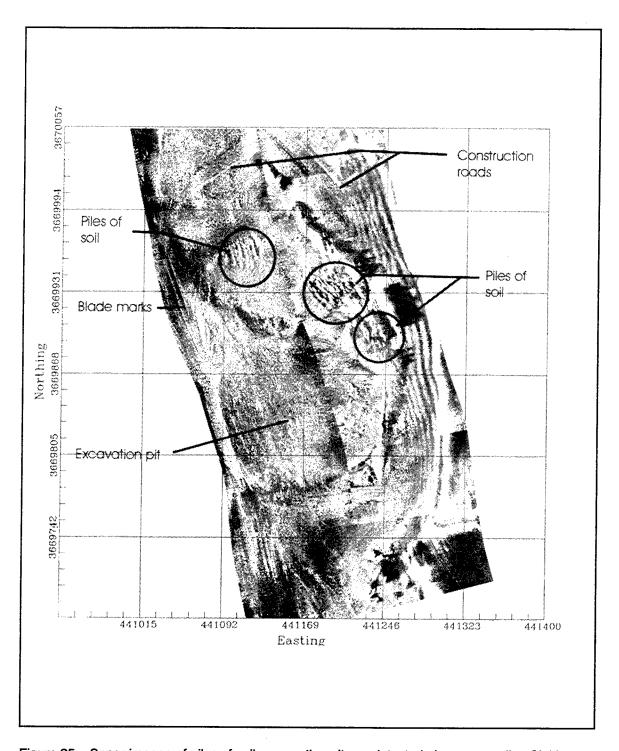
Figure 25. Sonar images of piles of soil, excavation pits as detected along survey line SL16

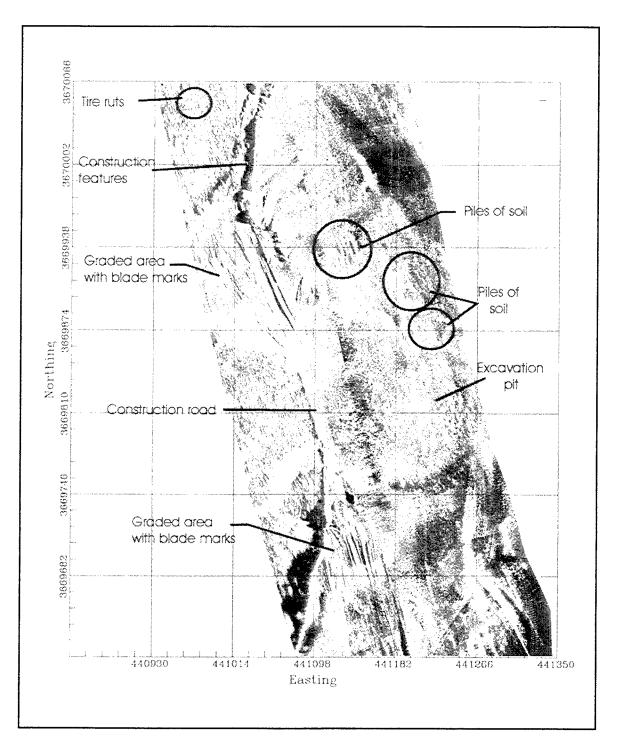
Figure 26. Sonar images indicating areas of construction activity near an excavation pit along survey line SL15 (see also Figure 26)

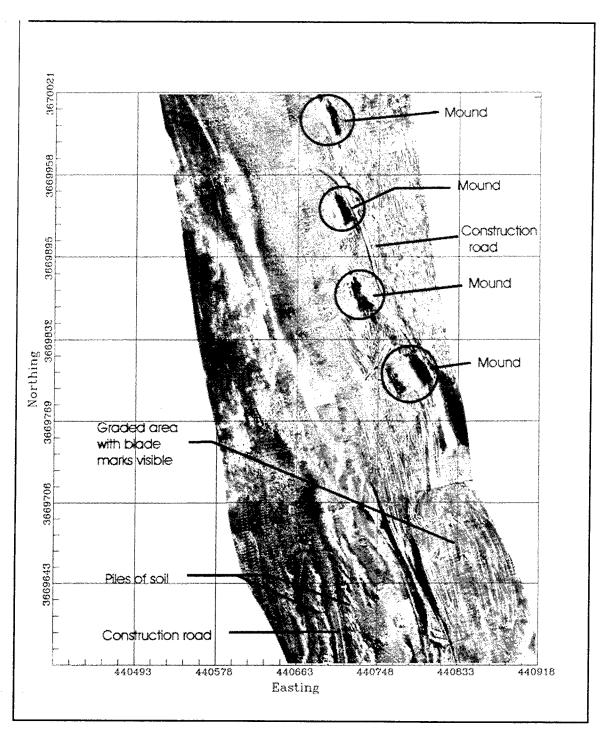
Sonar images of other construction activities are also detected in the vicinity of the dam as presented in Figures 26 and 27. Directly upstream of the dam and to the east of the original stream channel, a graded area is detected as shown in Figure 26. Blade marks caused by bulldozers or graders are clearly visible and indicate areas of either earth removal or soil placement procedures. Another area of earthmoving activity is located west of the original stream channel as shown in Figure 27. Although not all areas are presented, most of the reservoir bottom in the vicinity of the dam was graded during the construction phase of the lake.

Figure 27. Sonar images of a graded area and piles of soil as detected near the dam along survey line SL02. Also note the four mounds and construction roads

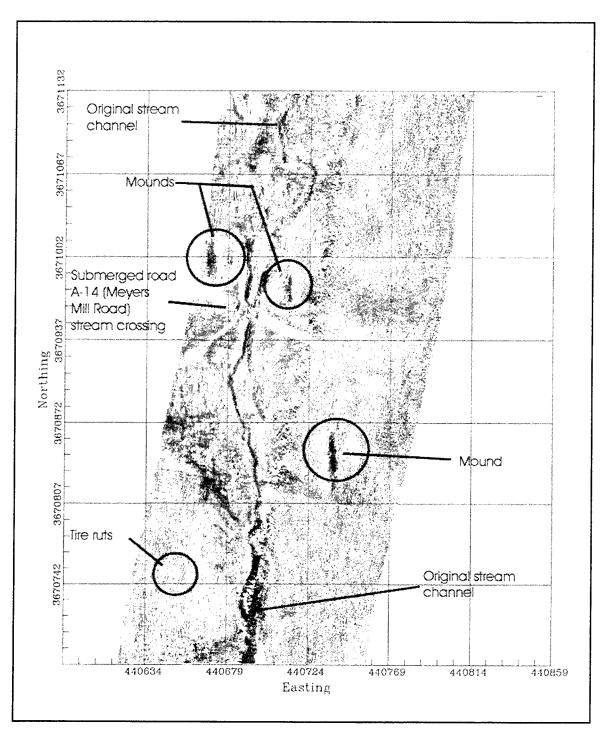
Figure 28. Sonar images along survey line SL03 of the old Road A-14 (Meyers Mill Road) stream crossing, at least three mounds, and the original stream channel

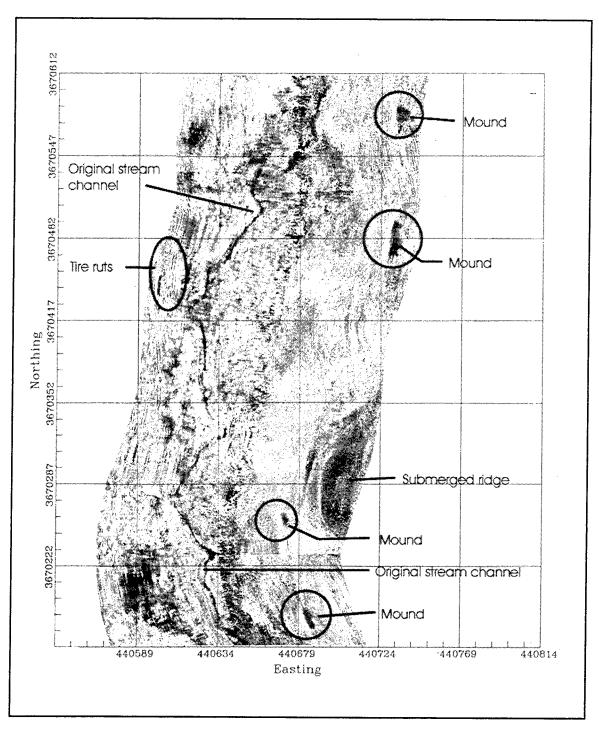
Interpretation of the sonar record suggests that some of the vegetation along the channel was not removed prior to reservoir filling. The images shown in Figures 29 and 30 provide additional views of the original stream channel and surrounding features. Seismic reflection data collected over the original stream channel imaged in the lower portion of Figure 30 was presented earlier in Figure 9.

Figure 29. Sonar images of the original stream channel and several mounds along survey line SL03

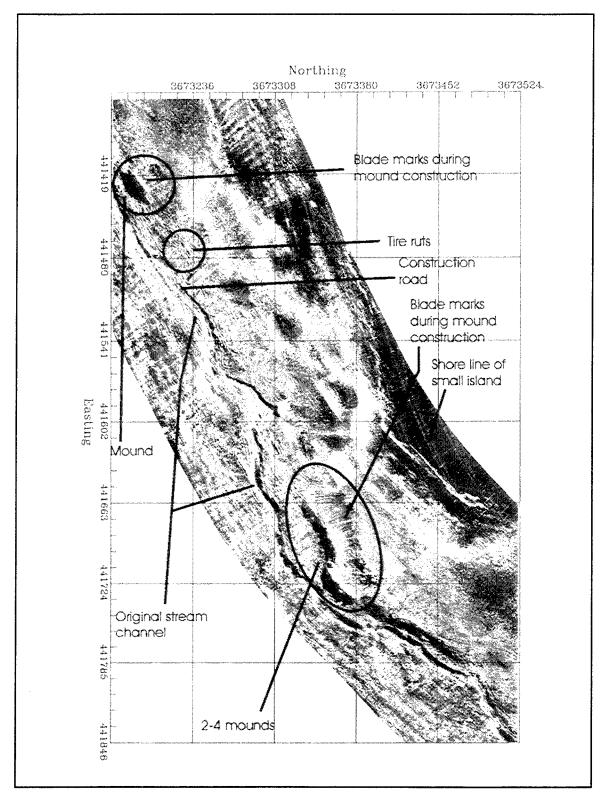
Figure 30. Sonar images of the original stream channel and several mounds as detected along survey line SL03
